# PRE PURCHASE STANDARD TIMBER PEST INSPECTION REPORT

ADDRESS OF PROPERTY INSPECTED: 25 XXXXXXXXXXXXX Street, Perth WA

DATE OF INSPECTION: XX-XX-2012

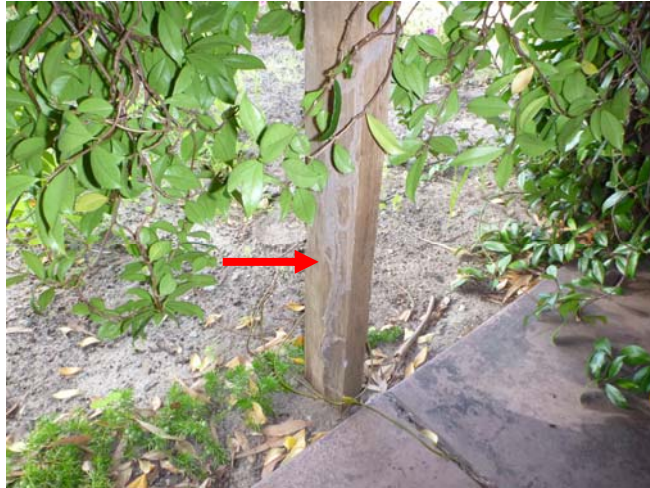
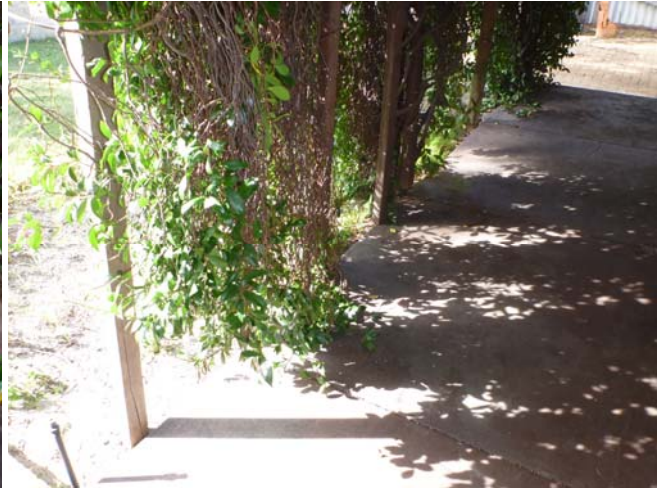
**D3 Termite workings and/or damage**

Timber made awning at the front of the house - one post was seen to be affected by termite damage. No live (active) termites were observed at the time of inspection. Damage to the post is significant. Please replace the post with a termite proofed one.

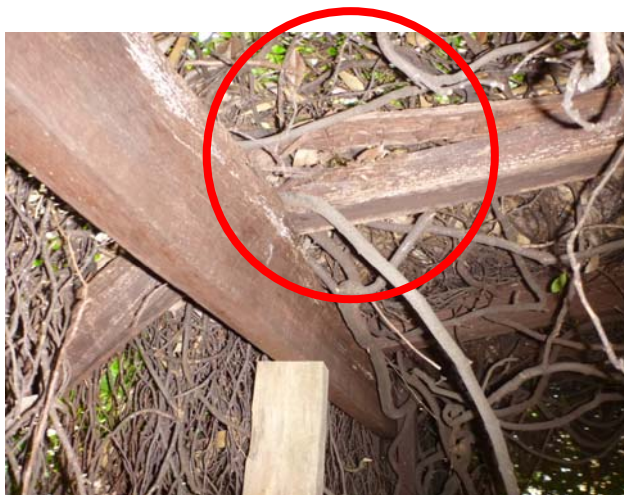
**D7 Fungal decay**

Some awning's timbers at the front of the house were observed to be affected by fungal decay and replacement may be required. For specialist advice please contact a licensed building inspector.

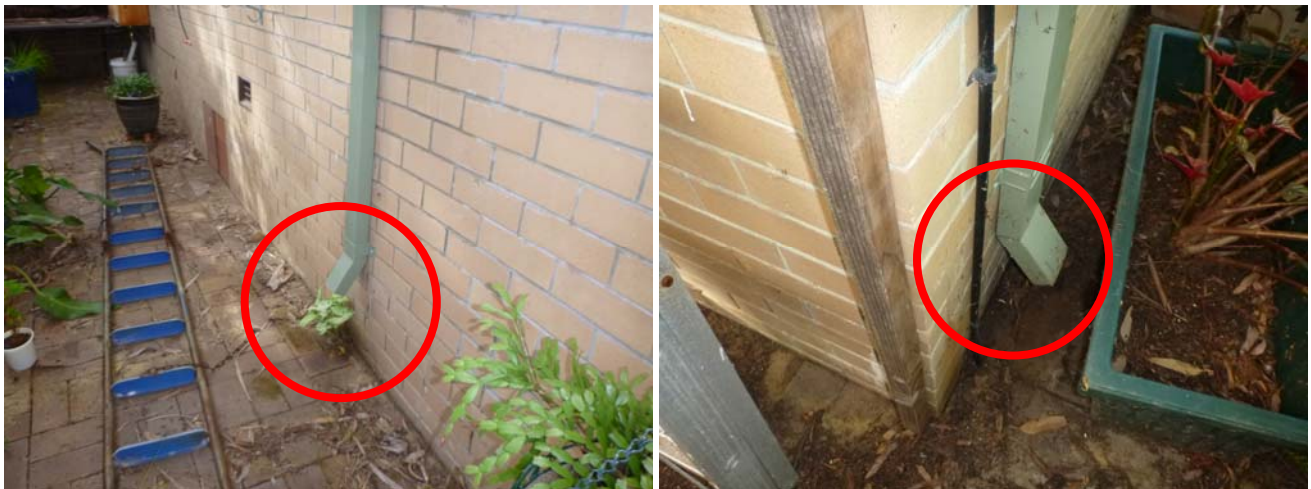
**D10 The presence of excessive moisture**

- Some downpipes need appropriate stormwater drainage.

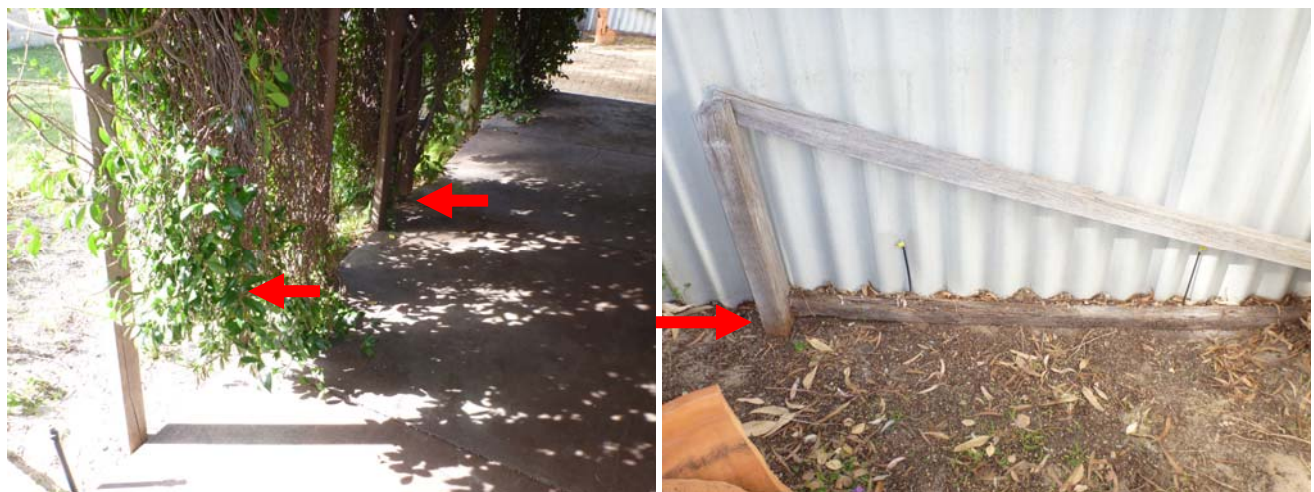
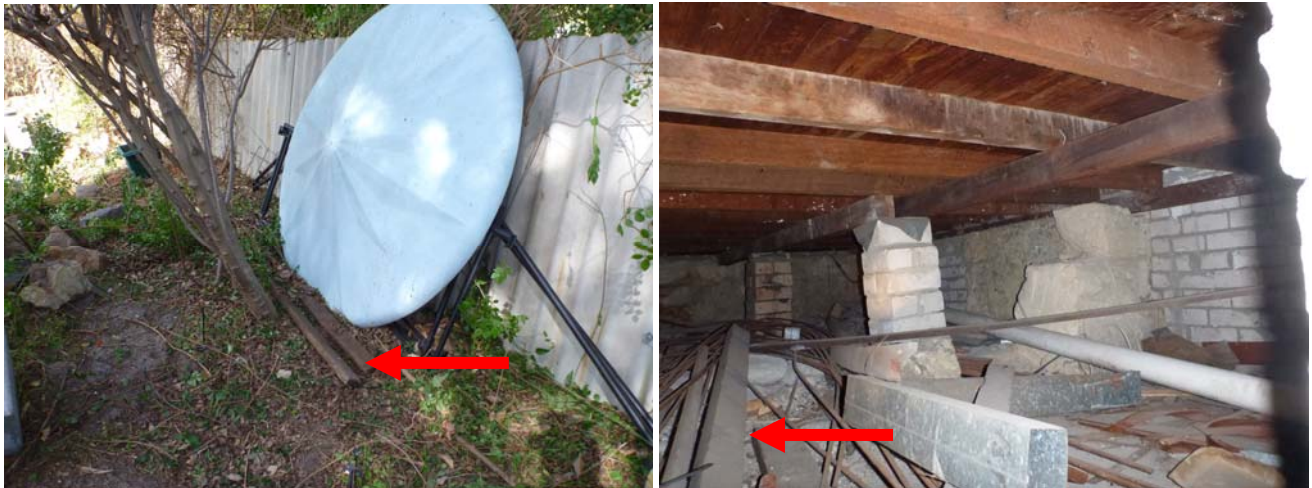
D12 Untreated or non-durable timber used in a hazardous environment

- Front awning posts in contact with ground
- Timber elements in the garden and sub floor (see pictures below)

The timber posts at the back where observed to be in contact with pavers/ground. Australian Standard AS 3660 requires all timber members which are not termite-resistant to stand on a corrosion resistant metal support with a minimum clearance of 75 mm above the finished ground level. Competent advice (e.g. from a licensed building contractor) should be obtained in regard to rectification work.

NOTE: Any timbers that are in direct ground contact being in garden areas or pergola/awning related should be removed or relocated unless evidence is provided that these timbers are of a treated or specific type suitable for its as applied application.

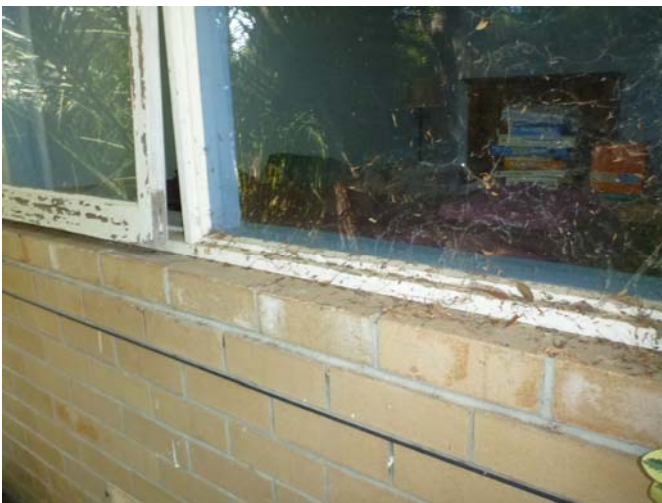
D13 Other conditions conducive to timber pest attack

Most of window frames were observed to be in a poor state of maintenance condition e.g. peeling off paint - renovation work is highly recommended to prevent fungal decay. Competent advice (e.g. from a licensed building contractor) should be obtained in regard to rectification work.
